## TEST REPORT

**Lucideon Reference:** 193325 (QT-56508/1/JB)/Ref. 1

**Project Title:** Testing of Spig-Lite Pro Balustrade System whilst Submerged in Water in Accordance with BS 6180:2011 Barriers In and About Buildings

**Client:** Pure Vista Ltd  
Pendewey  
Stony Lane  
Bodmin  
Cornwall  
PL31 2QX

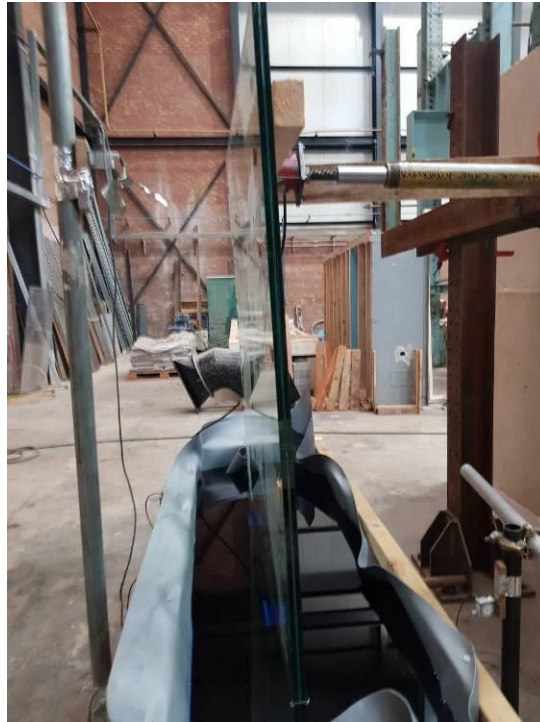
**Plate 1** - Generic Test Configuration

A horizontal imposed line load was applied to the glass at 1100 mm above the datum level of the floor and the deflection measured at the horizontal centre points of the panel. The load was applied via a hydraulic ram and the deflection measured using a linear voltage displacement transducer (see Plate 1).

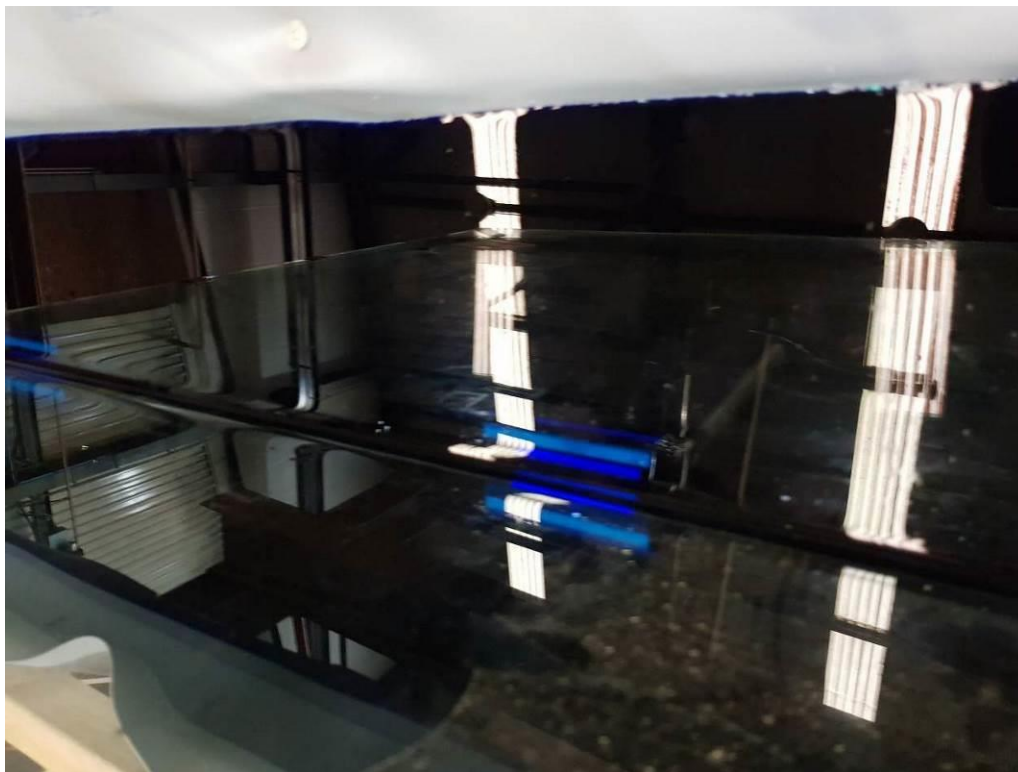
**Plate 2** – Spig-Lite Pro Submerged in Water

The plywood tank was filled with water to a level slightly above the Spigots. Blue dye was added to the water to aid with the visual assessment during the deconstruction on conclusion of the test. Any water ingress would be highlighted by blue staining.

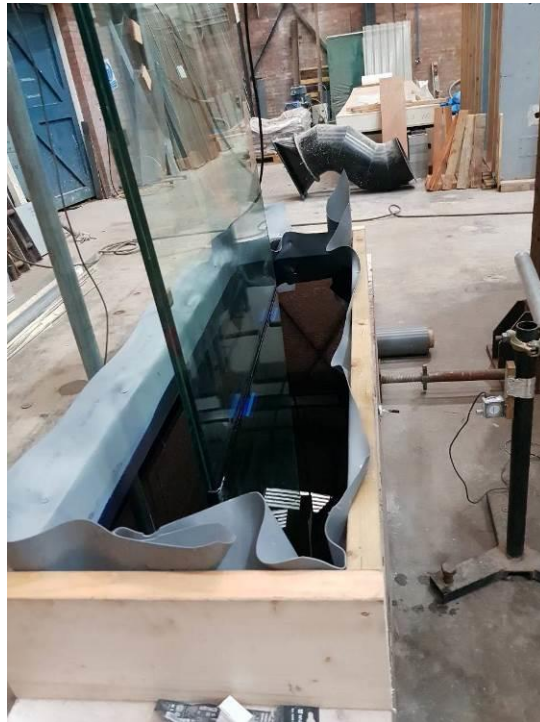
**Plate 3** – Spig-Lite Pro Submerged

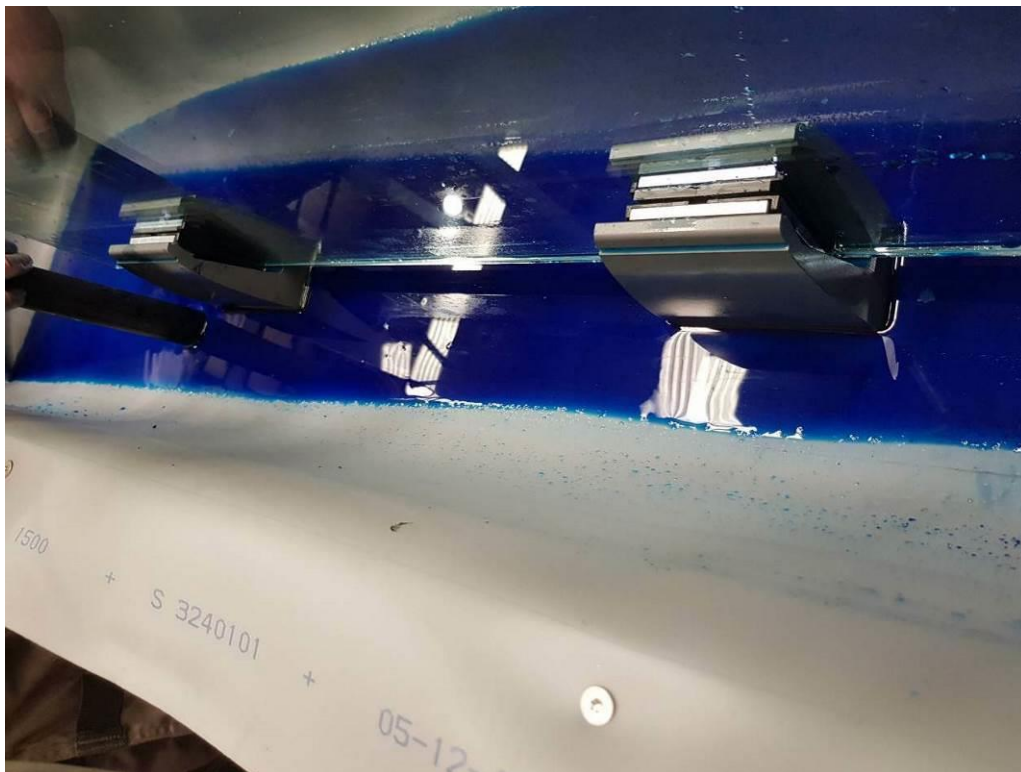
**Plate 4** – Draining of the Tank after Test

A load of 0.85 kN/m was applied giving a deflection reading of 25 mm and then held for a period of 24 hours. The load was then released, the plywood tank emptied and the system deconstructed.

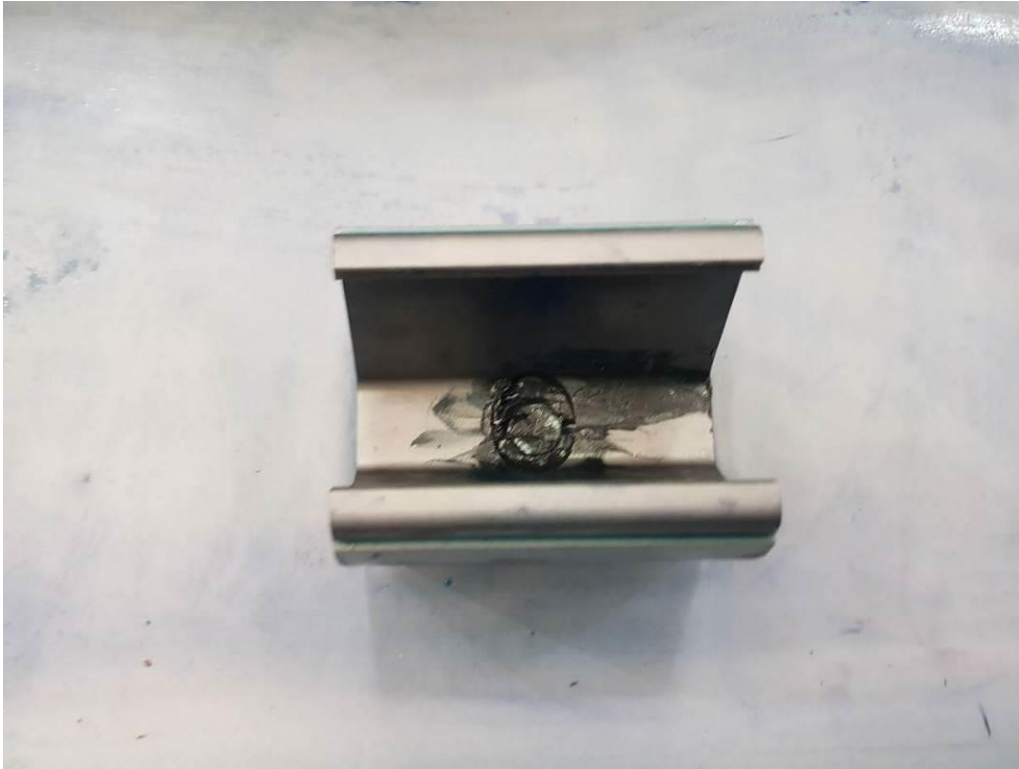
**Plate 5** – Spig-Lite Pro on Deconstruction

On emptying the tank the system was deconstructed and visually assessed for signs of water ingress. Each component was individually assessed and the membrane removed to expose the underlying concrete block. No evidence of water ingress was found. Any water ingress during the test would have been highlighted by the blue dye and the system was found to be completely free of staining. Photographs showing each stage of the deconstruction can be found in the Appendix.

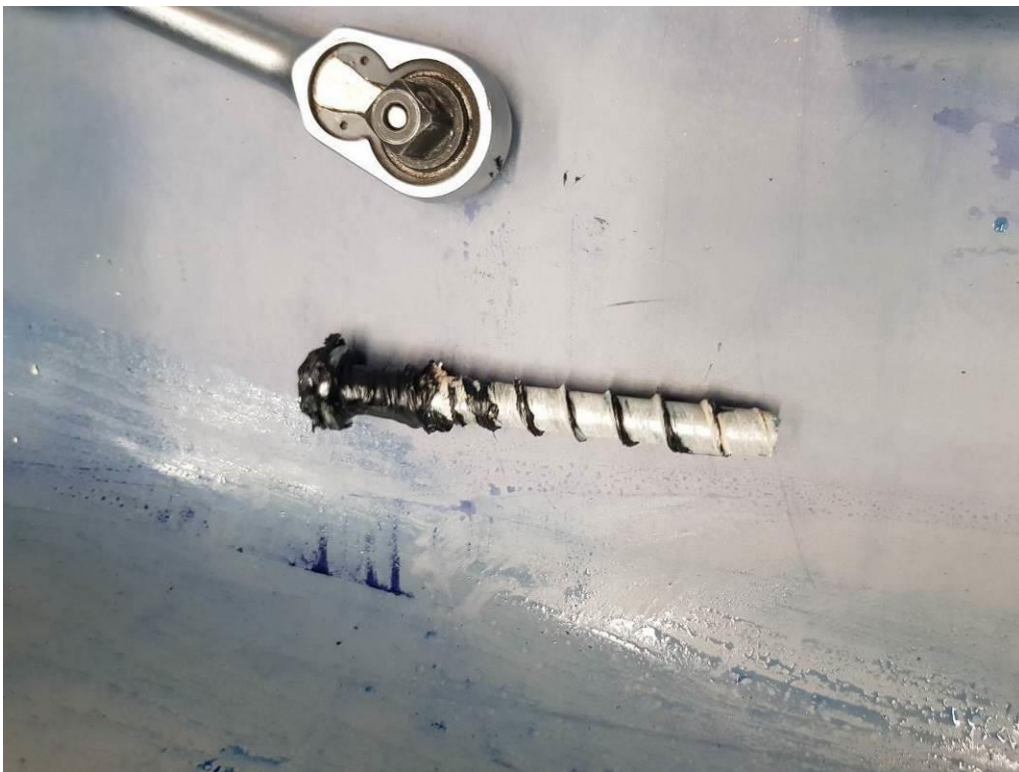
**Plate 6** – Concrete Bolt used to Anchor Balustrade System

The spigots were bolted to the block using high performance M12 Concrete screw bolts. Two spigots were fixed per metre using a single bolt per adaptor. The glass panel was fitted into the adapters using the glass slip clamping system.

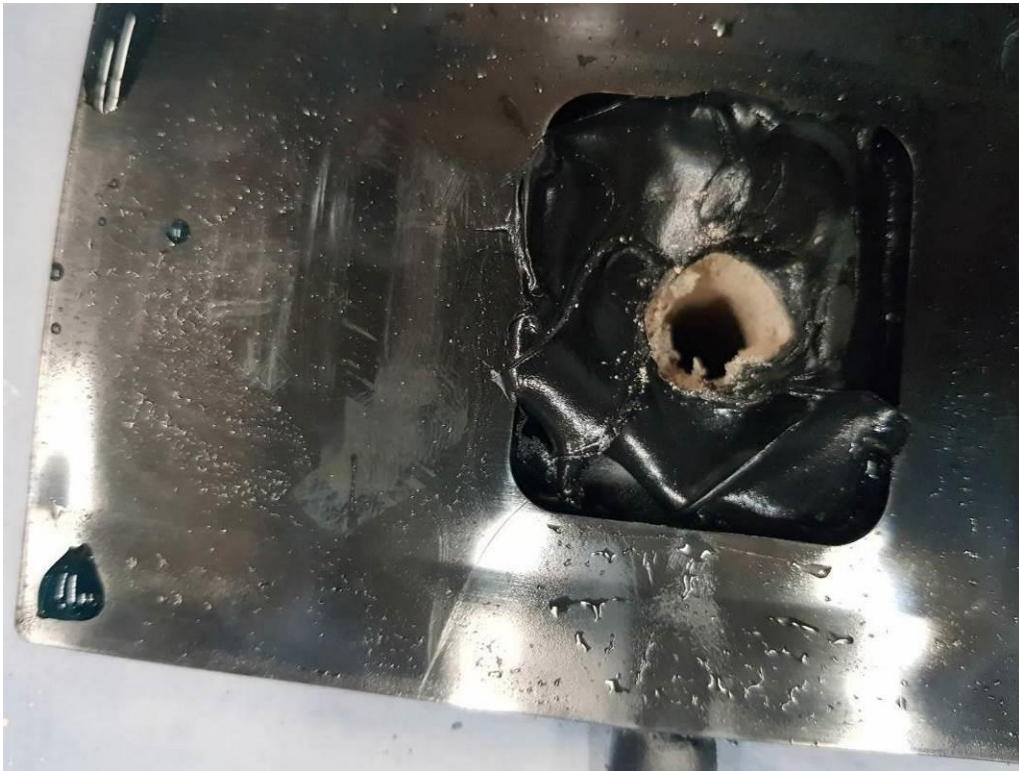
**Plate 7** – Block after Deconstruction

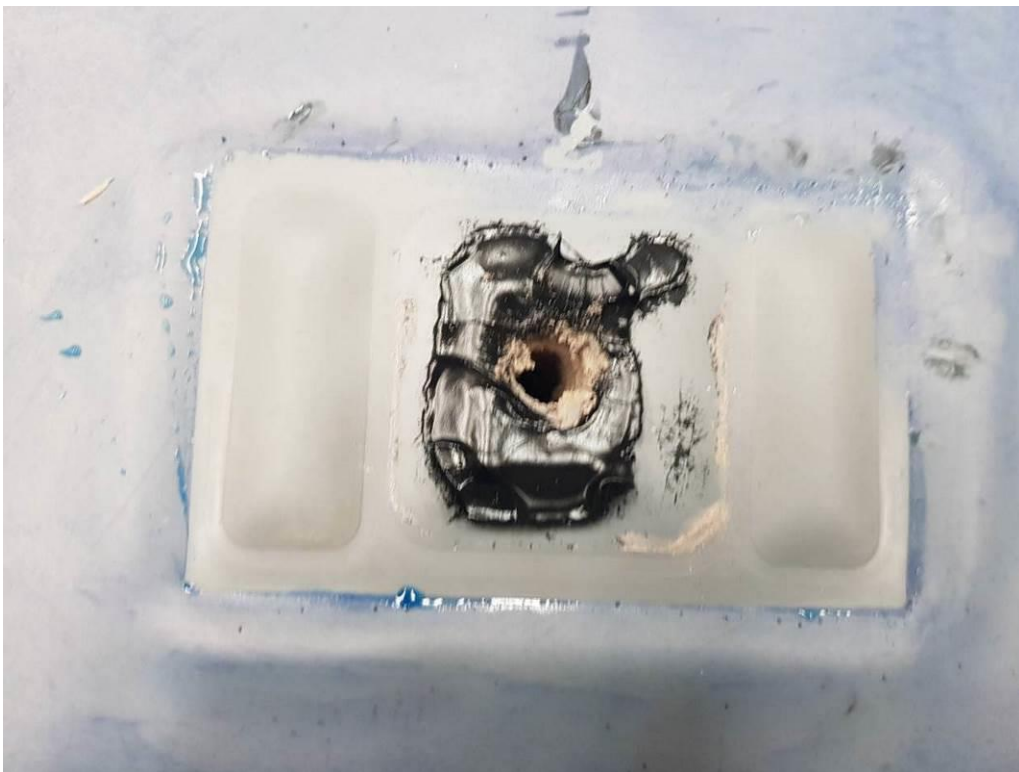
**Plate 8** – Waterproof Membrane after Deconstruction

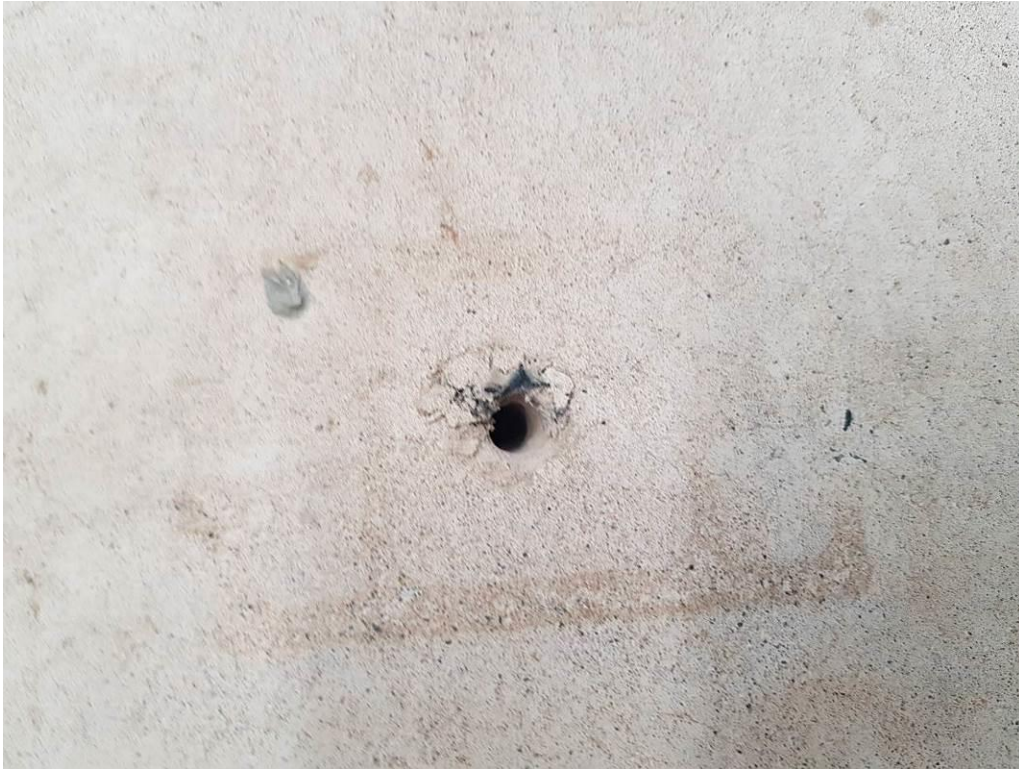
**Plate 9** – Concrete Slab after Deconstruction

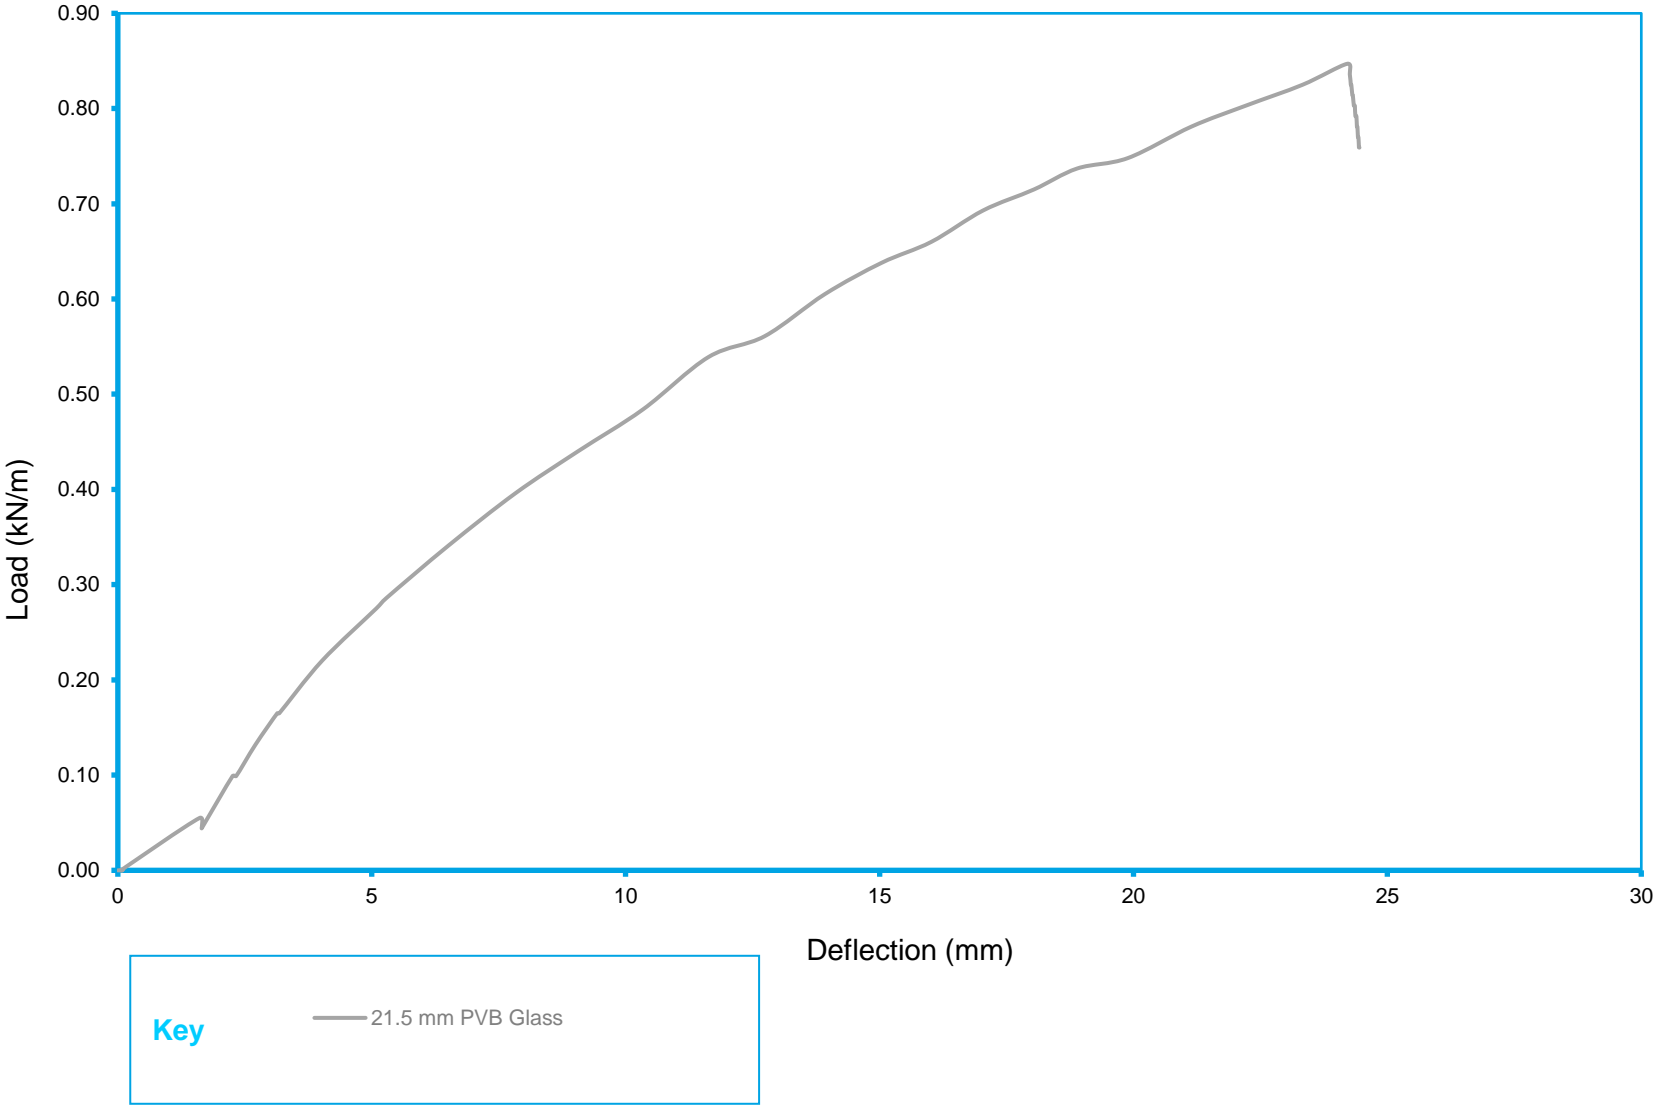
**Chart 1 - Load Deflection Curve for Pure Vista Spig-Lite Pro System Incorporating 21.5 mm PVB Glass Whilst Submerged in Water**

Fix	Glass Type	Load Application (mm)	Transducer Position (mm)	Imposed Line Load at 25 mm Deflection (kN/m)	Working Line Load for System (kN/m)	Deflection at Working Line Load for System (mm)
Concrete (Submerged under Water)	21.5 mm PVB	1100	1100	0.85	0.74	18.89

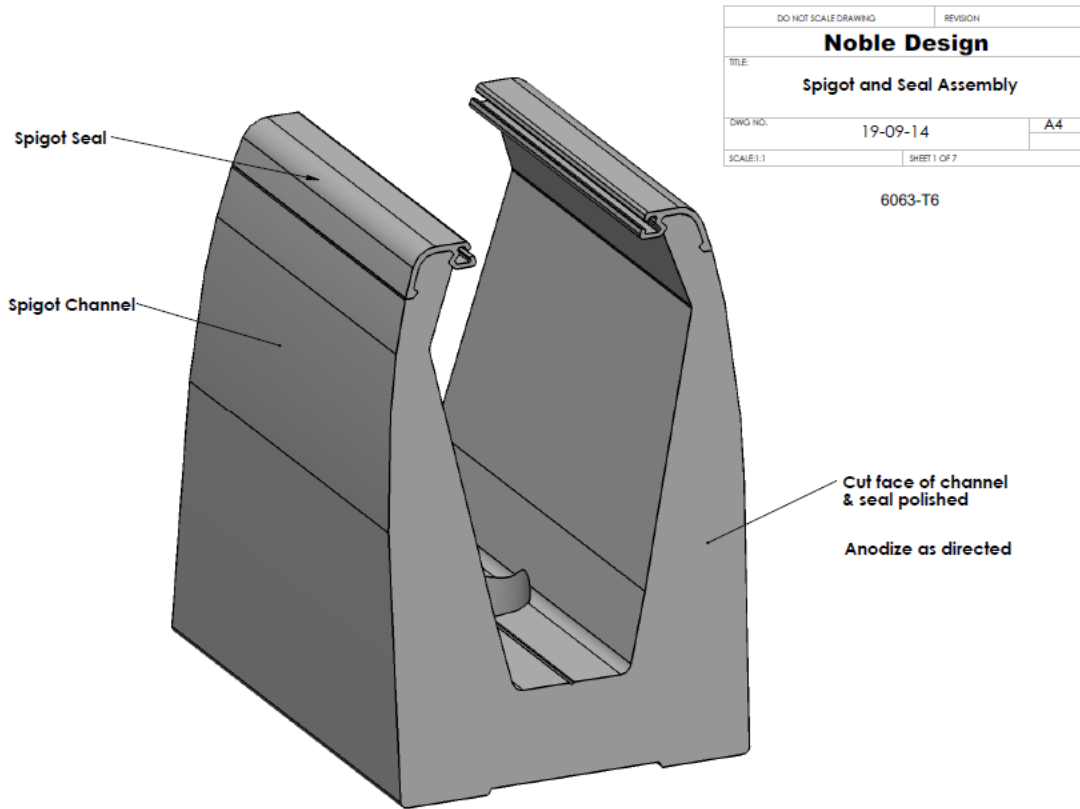
### APPENDIX 1 - Spig-Lite Pro

### Concrete Fixing - High Performance W-HAZ-S/S anchor
